Cleaning and protection of a castle wall of pumice tuff which carried out many years past. 0805.06.
The protection repair work of Edo castle wall and the remains of a rampart

Cleaning and protection of a ground stop wall of pumice tuff which carried out many years past.0805.06

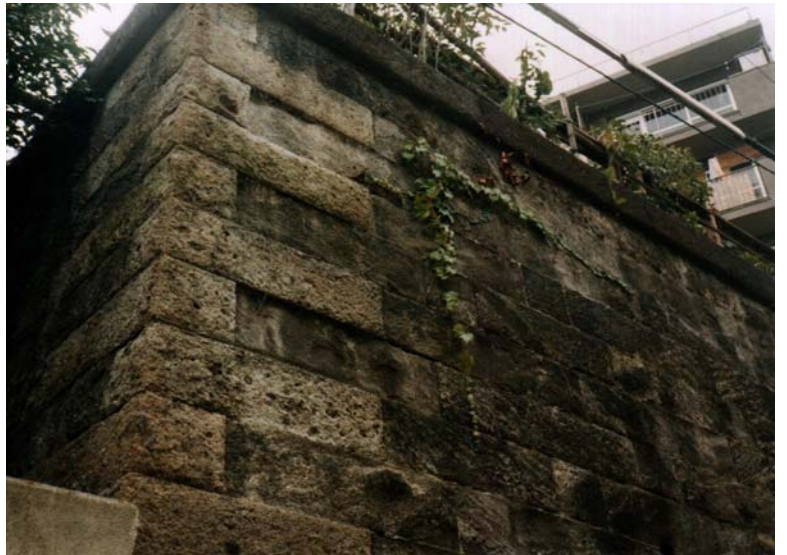
pumice tuff present condition and the root of an ivy, moss make the surface weak

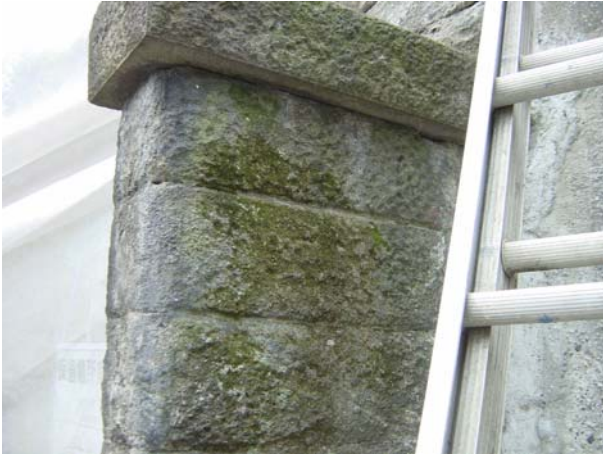
The dirt of pumice tuff which carried out many years past is conspicuous.

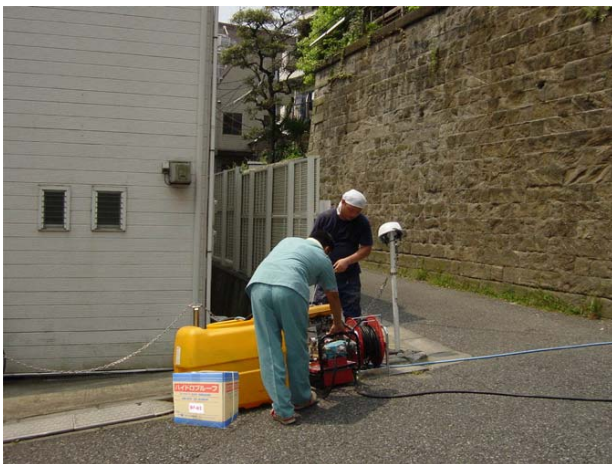
Washing preparation

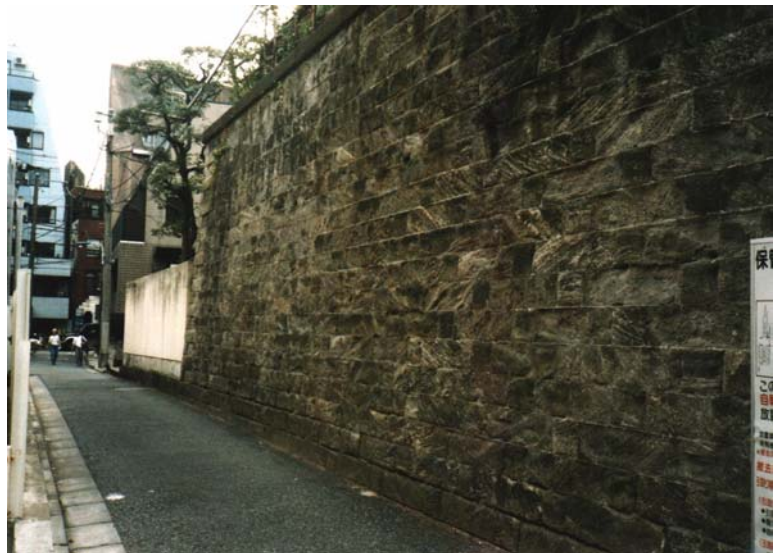
The dirt of pumice tuff which carried out many years past is conspicuous.

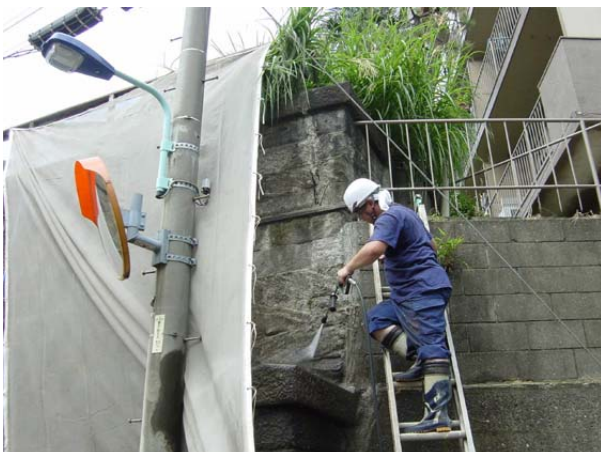
Before washing and the alga of a ground wall overgrow firmly.

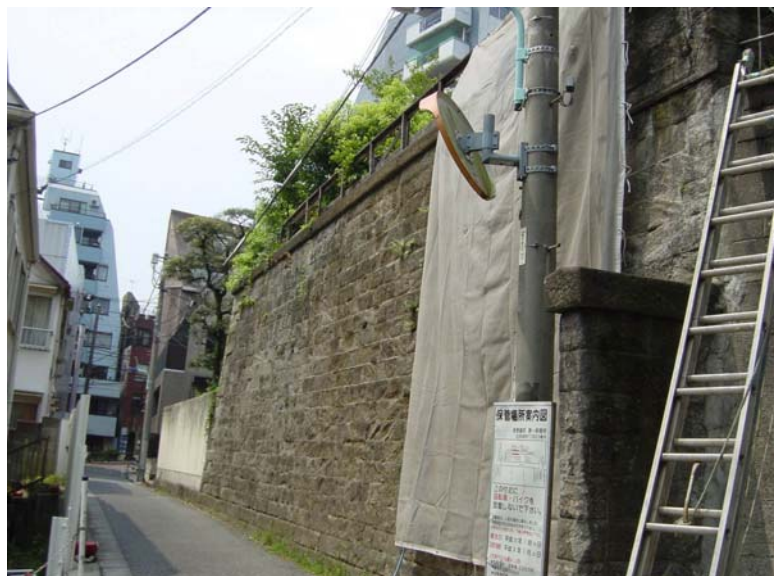
It is the take sheet care so that it may not disperse before washing and around ground wall.

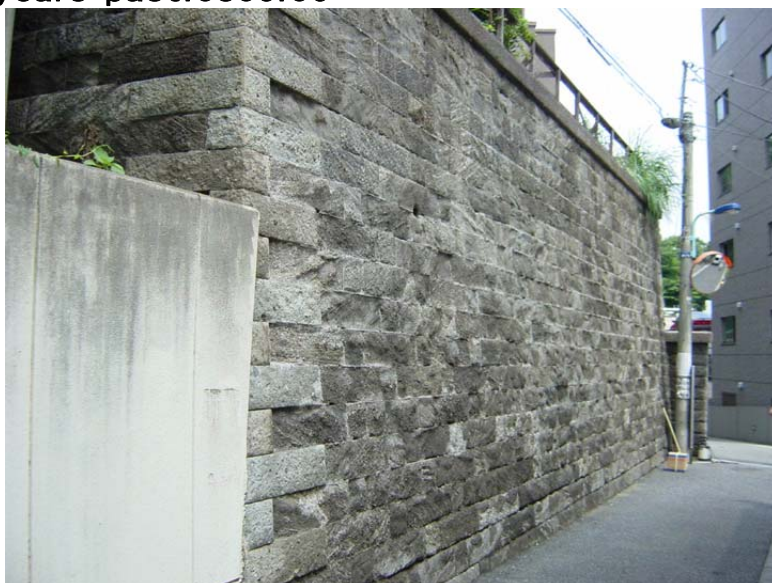
Washing although it became beautiful next morning completely it still gets wet color and is not settled

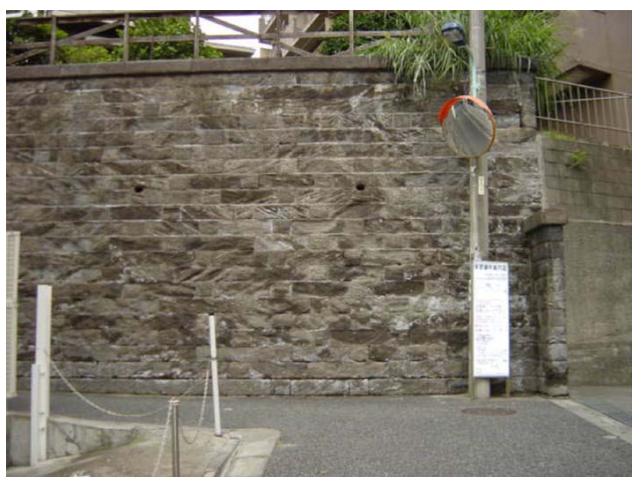
Completion of waterproofing protection.

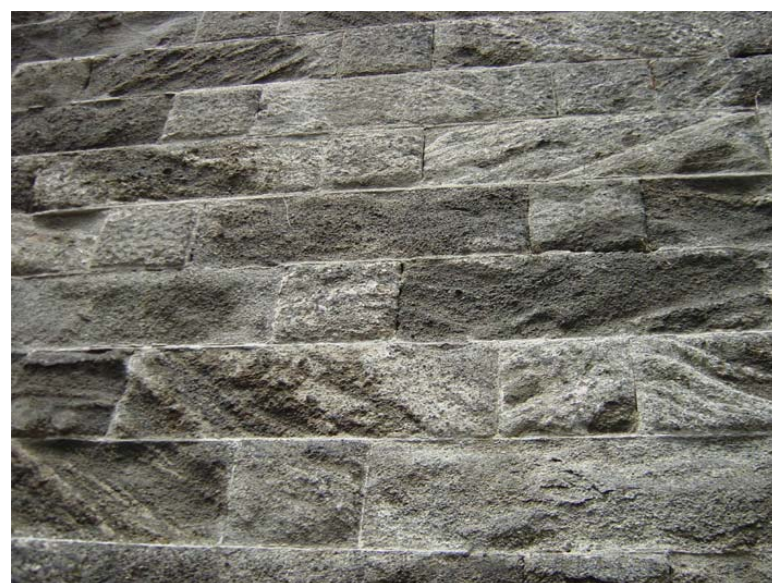
The ground wall surface after washing and a black portion get wet with rain last night and a color does not pull them.

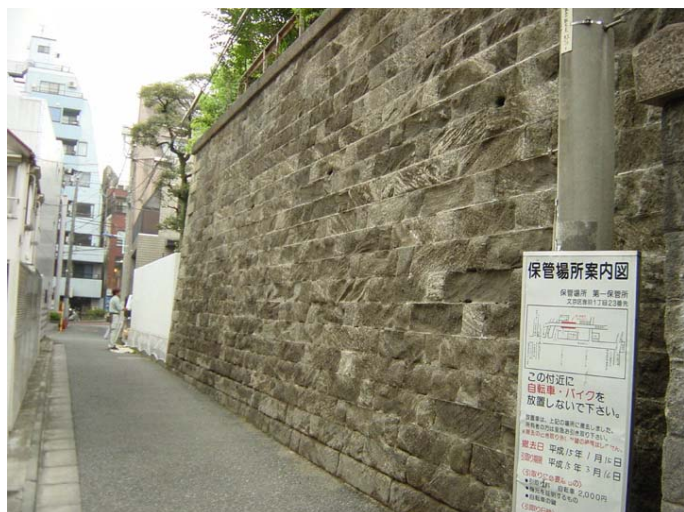
The completion of construction

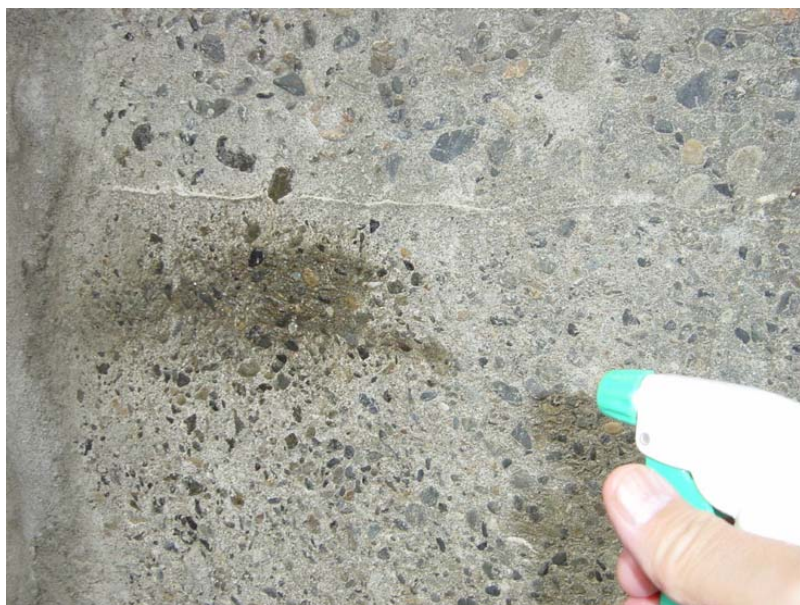
Water is poured on a non-constructed portion by the spray. Water is sucked in as seen.

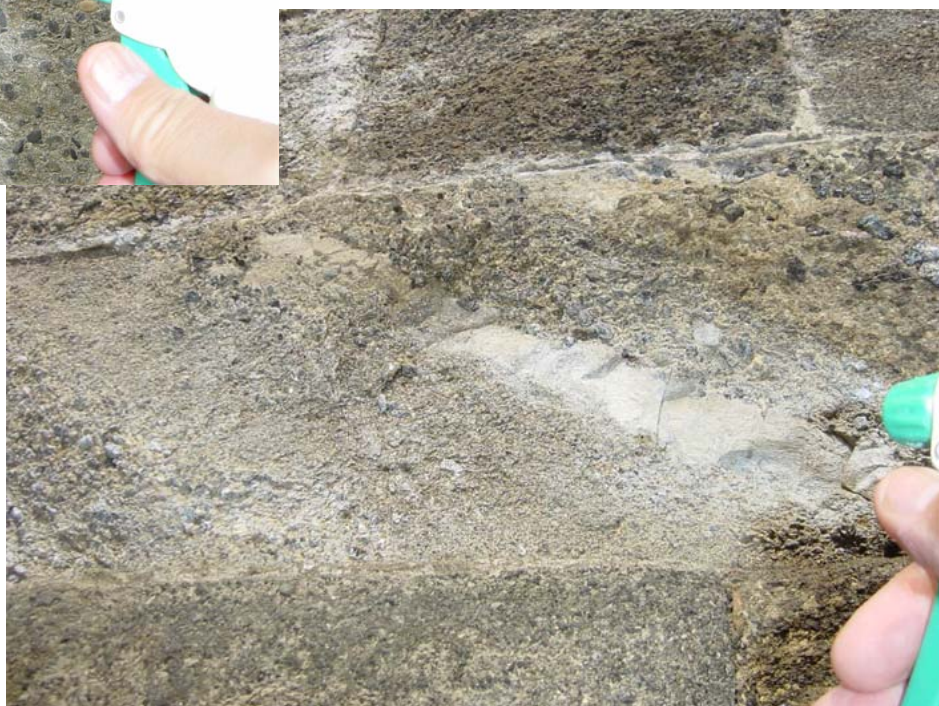
Water does not sink in.
