# **The flood from Tile joint is prevented. The repair work asked for an odorless material**

Construction name : "Susitei" Thailand kitchen waterproofing construction

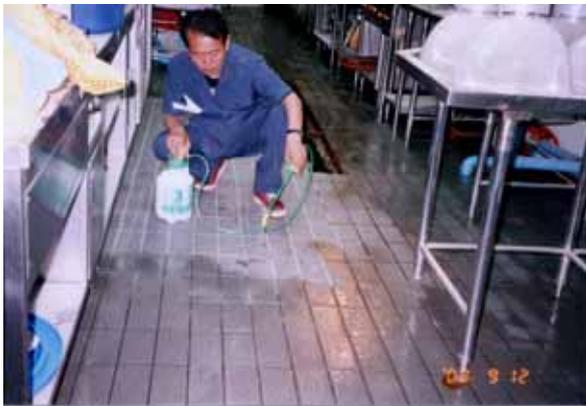
Construction at a spot

Weight apparatus is constructing without moving so that it can judge from a construction photograph. Moreover, it can construct, if it is in the wetting state which is the grade which accumulates in a ground and does not have water, and it is thought that the adaptation range of a method of construction is expandable. Although there is no leakage of water and the deck brush is washing the floor every day now as a result of the watering examination after the completion of construction, leakage of water is not checked but is continuing maintaining waterproof ability.

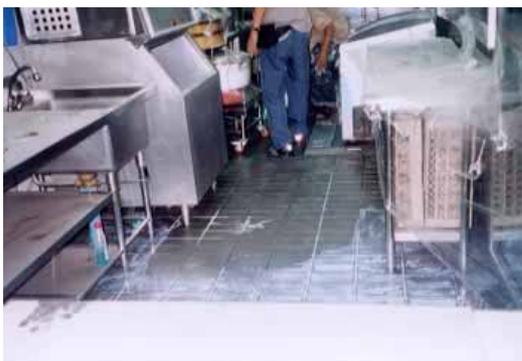
It permeates from joint of a tile.

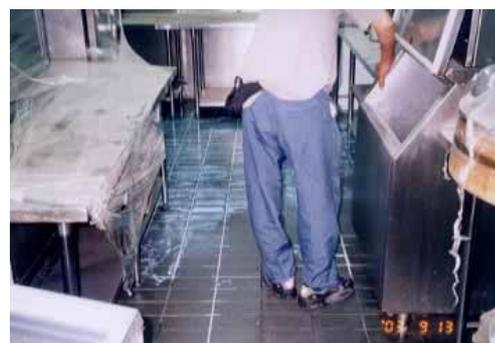
The application situation in kitchen.
